DEPARTMENT OF NATURAL RESOURCES Division of Oil, Gas & Mining

JOHN R. BAZA Inspection Report

Mine Name: Indian Queen **Operator Name: Gary Applegate**

Permit number: M010019 Inspection Date: 08/01/2006

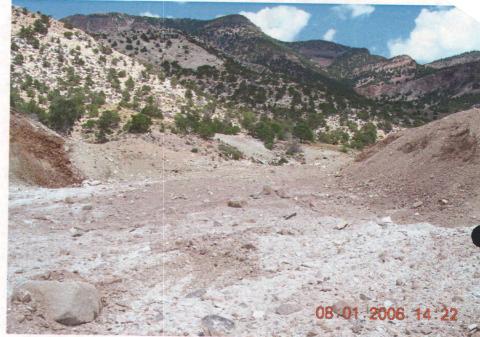
ACCESS TO UPPER PIT REMOSED

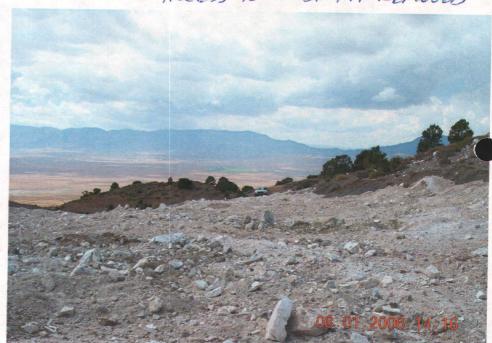
LOWER PAD LOOKING WEST

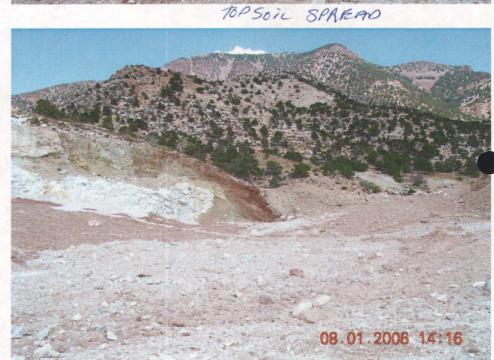
LOWER PAD

TOPSOIL SPREAD

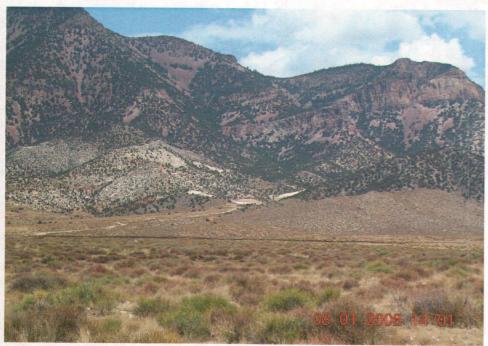
SITE FROM A DISTANCE

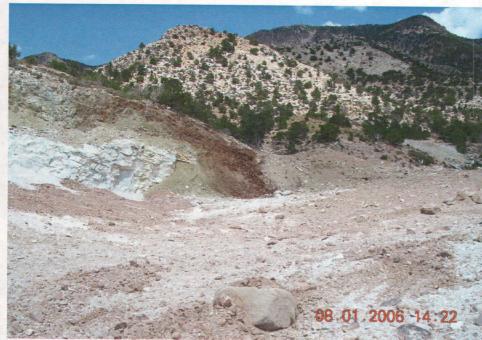
HIGHWALL COVERED UD

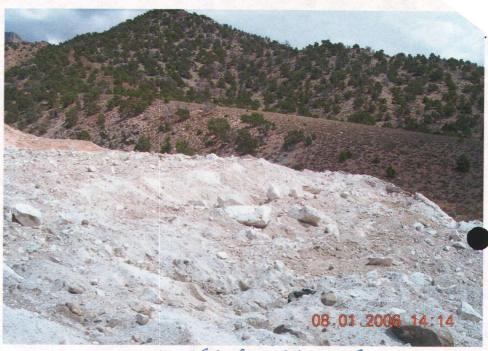
LOWER PAD REGRAPED

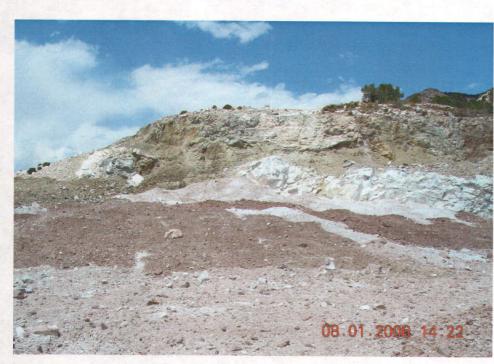
LOWER HIGHWARE RECLAIMED

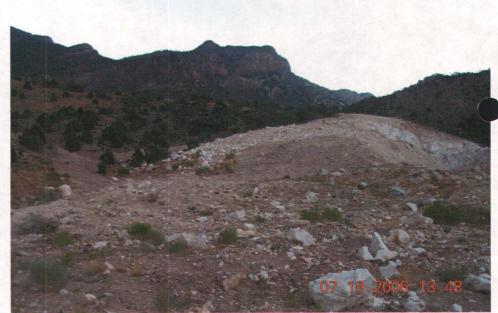
UPPER PIT REGRADED

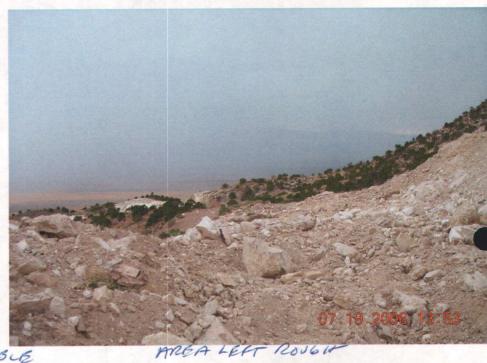
HIGHWALL BURIES TO EXTENT POSSIBLE

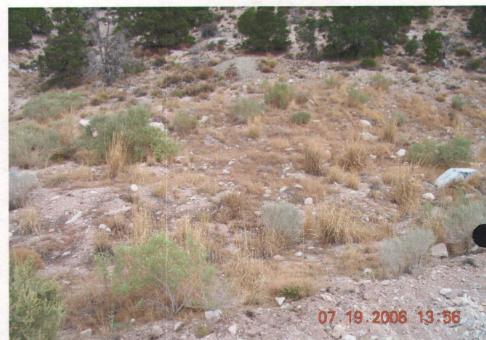
ACCESS TO WEST TO LOWER PAD

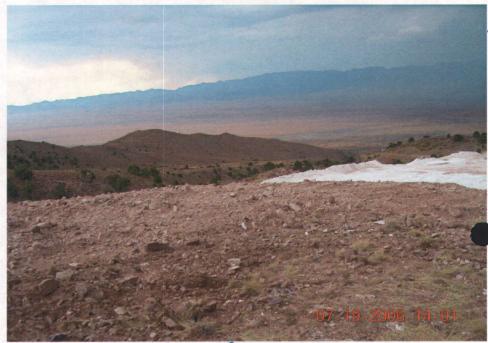
LOWER PAD I MONTH BEFORE FINAL RECLAMATION

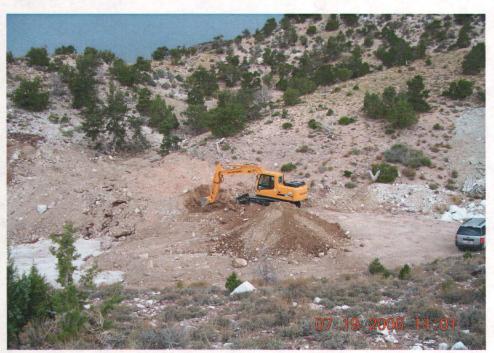
WORKING ON LOWER RAD RECLAMATION
